Assessment of Vehicle Fires in New Zealand Parking Buildings

Fire Engineering Research Report 04/2
May 2004

**A thesis submitted in partial fulfilment of the requirements for the
degree of
Master of Engineering in Fire Engineering**

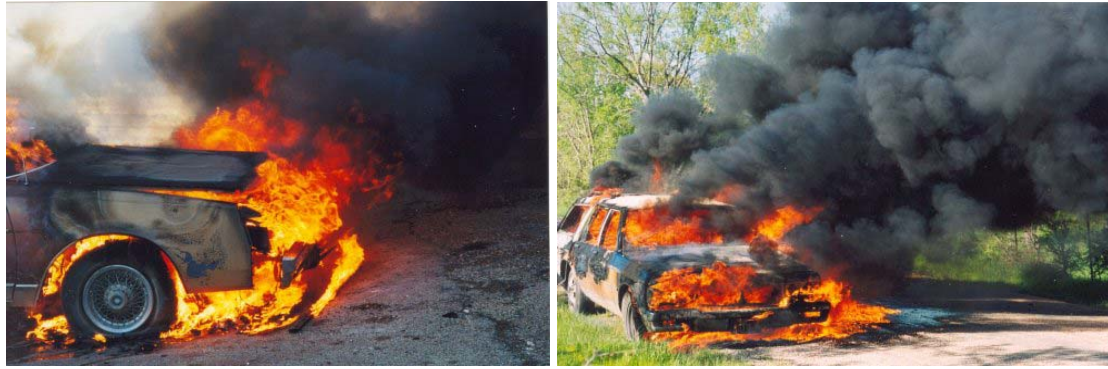
Figure 1-1: Car fire photos (Photo by Wayne Tomblinson www.amazingfirephotos.com)

The case studies presented above highlighted the extent of hazard by vehicle fires in parking buildings to both human life safety and property protection. In particular, that smoke generated by the burning vehicles poses a great danger to life safety. The following photos in Figure 1-1 visually demonstrate the severity of burning and the amount of smoke generated from a single vehicle fire.

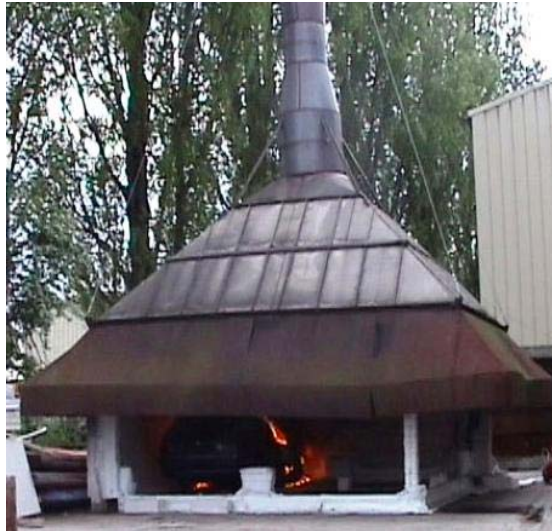
Figure 2-3: Test configurations and HRR curves, reproduced from Schleich et al. (1999)

Calorimeter hood

Configuration for Test 9

HRR (MW) vs time (min) for five car fire tests and proposed reference curve

In 1995 and 1996, CTICM in France performed a total of nine car fire tests (Schleich et al., 1999) in a calorimeter hood as shown in Figure 2-3; it could accommodate two cars and simulated a closed car park. The tests involved different ventilation conditions and burning of one or two cars in a single test. The test cars were placed on a weighing platform; the combustion products were collected by a hood above the car park. Some steel members were placed in the calorimeter hood, and their conditions observed when exposed to vehicle fires.

The measurements taken for each test included HRR, mass loss rate, heat fluxes, steel temperatures, gas temperatures and toxic products. The first six tests involved cars manufactured during the 1980's and new cars were used in Test 7, 8 and 9. The tests showed that the energy released by a car made in 1995 was twice that of a 1980's car. Some of the HRR results can be found in Figure 2-3.

Based on these tests, the report introduced an HRR reference curve for fire engineering design. This curve is shown in Figure 2-3 with the test results. A “wave” theory was also proposed in this report to account for the fire spread between multiple vehicles in a closed car park. According to this “wave” assumption, the cars will burn one after another, with a delay time of 12 minutes. By examining the HRR reference curve, one can infer that the fire of first car will start to decay when third car starts to ignite at around 24 minutes. It was also concluded that the fire can be confined within

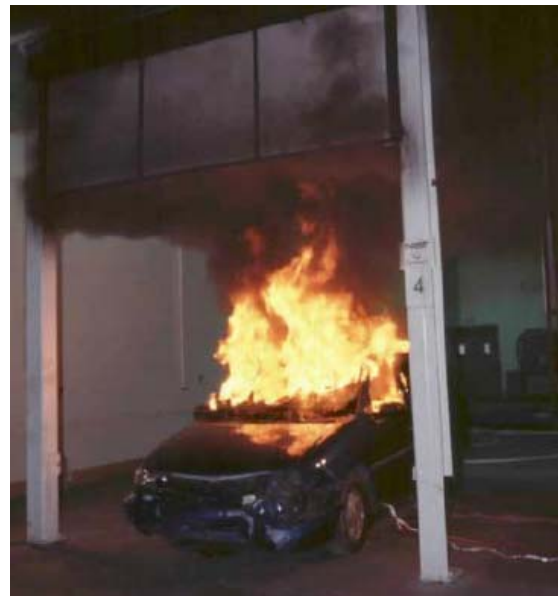
Figure 2-7: HRR (kW) vs time (min) for a minivan fire and a test photo, reproduced from Stroup et al. (2001)

HRR (kW) vs time (min)

Burning after the crack of front window

In the first test, the windows were all closed and fire was started by ignition of approximately 0.317 kg of paper in the passenger compartment. The fire went out due to lack of the oxygen. In the second test, 2 litres of gasoline was ignited in the passenger compartment with the driver and passenger windows open. As the fire developed, the closed windows broke and fell out; the condition of burning at this point is shown by the photo in Figure 2-7. The fire was extinguished at approximately 4 minutes (240 s) after ignition. The HRR as a function of the time was shown in Figure 2-7, with a peak value of 2.4 MW. Temperatures and gas concentrations were also measured at various locations within the passenger compartment during the test.

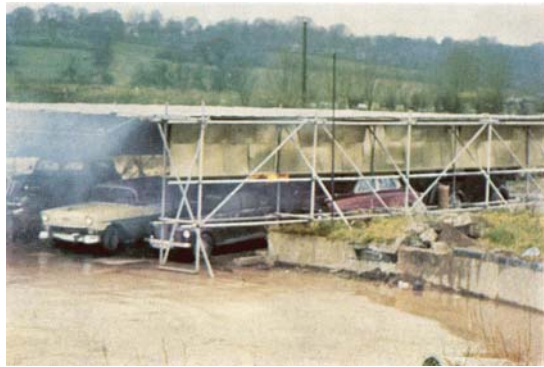
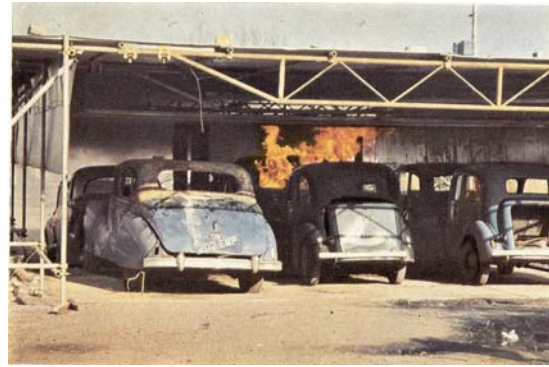
Figure 2-13: Car fire test photos, reproduced from Butcher et al. (1968)

General building assembly

Fire seen two minutes before full development in Test 2

Butcher et al. (1968) reported three car fire tests in a specially built steel scaffolding structure shown in Figure 2-13, with an insulated ceiling approximately 2.1m above the floor. The two ends of the structure were left open for the first and second tests, and closed for the third test. Nine cars in a three by three array were arranged with parallel spacings ranging from 0.75 m to 1.2 m. The tanks of all tested cars were filled with 23 litres of petrol and a considerable amount of combustible material was also put inside the car to represent the luggage.

The car located in the centre was ignited first in each test. The windows of ignited car were all closed except for the driver seat window, which was left half open. After ignition, the flames were observed out of windows at 8.3 and 12 minutes for first test and second test respectively. The condition at two minutes before full development of the fire in Test 2 can be seen in Figure 2-13. The fire was reported burning through the fabric section of the roof for Test 3 where a small soft top saloon was used and wind velocity was higher than the first two tests.

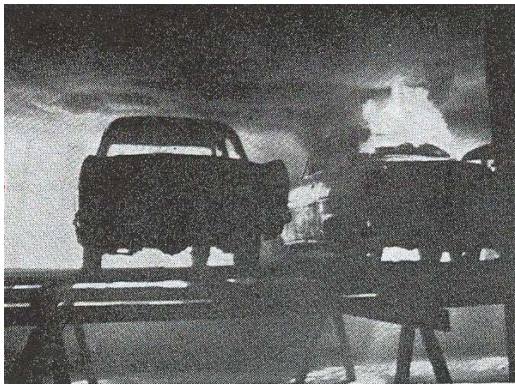
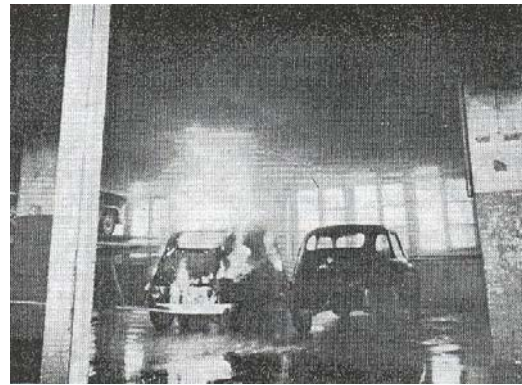
Figure 2-14: Car fire test photos, reproduced from Burgi (1971)

Test 1 – Fire at 28 minutes after ignition

Test 3 – Fire at 1 minute 20 seconds after ignition

Burgi (1971) reported three sets of car fire tests carried out in a factory building designated for demolition. This was a closed structure of irregular shape with an area of 525 m² and a ceiling height of 3.7 m. The sprinklers were installed to assess the effectiveness of the fire extinguishing system. The cars used in the test were all obsolete vehicles with petrol tanks two-thirds full. The front windows of the ignited car were left half open. The air temperatures inside the structure were measured during all tests.

The first test involved three cars, parked with normal spacing between each, on a platform 1 m high. The centre car, containing a carton of combustible objects, was first ignited by electric soldering iron. The fire smouldered for 18 minutes, at which point windows broke and the fire became more severe (due to sufficient ventilation within the compartment). Sprinkler system was activated by fire at 28.5 minutes and two minutes later smoke completely filled the structure. The fire did not spread to the adjacent cars. Figure 2-14 shows the test condition at 28 minutes, which was a half minute before the sprinklers activated.

The configuration of the third test was similar to the second test, except for the ignition which was started by petrol in a container placed under the car to simulate arson. The test condition at 1 minute 20 seconds after ignition can be found in Figure 2-14. Intensive fire development was observed in the ignited car; the fire was finally extinguished with foam. The side and left rear tyre of the adjacent car was damaged.

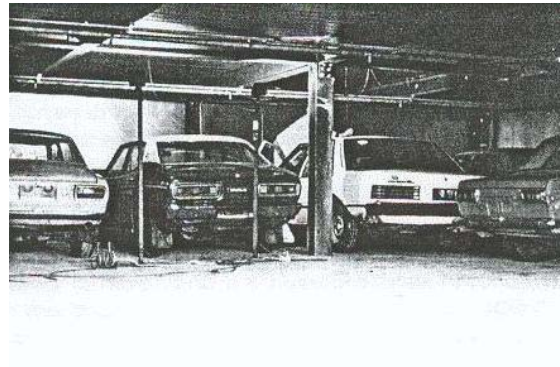
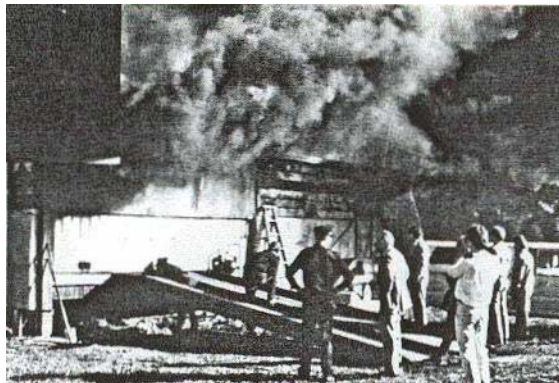
Figure 2-17: Car fire test photos, reproduced from BHP (1987)

For five tests where the sprinkler system was operated manually, the fire burnt through the test car. In two of the tests where more recent cars were used, the fire spread from the test car to those cars parked at both sides and rear. The maximum temperature in steel reached above 400°C in these tests and smoke and toxic products were produced for a long period.

For the remaining three tests where the operation of sprinkler system was automatic, the fire was rapidly controlled and confined within the test car. The fire spreading between parked cars did not happen and the maximum steel temperature was less than 100°C. The amount and duration of the production of smoke and toxic products were also reported to have been reduced.

Closed test structure

Vehicles before the test with sprinklers installed overhead

Thick smoke emitting out of the structure during the test

View inside structure during the test

A total of nine tests (BHP 1987) were performed in a closed car park building as shown in Figure 2-17, which was modified from the car park structure used in previous open-deck car fire tests. Twenty cars were used in these tests with various parking configurations; one photo in Figure 2-17 shows one of the vehicle arrangements. A sprinkler system was installed with a typical layout as permitted under AS2118 – 1982. A mechanical ventilation system was also installed in the test building. The measurements taken during the tests included inside air temperature, steel temperature, smoke optical density, carbon monoxide concentration, hydrogen chloride concentration and hydrogen cyanide concentration.

Smoke was observed to fill the building rapidly in all eight tests and the subsequent untenable condition could pose a hazard to life safety; this can be seen from one photo in Figure 2-17. The conclusion reached in this report was that the sprinkler system was the major factor controlling the car fire development in a closed car park.

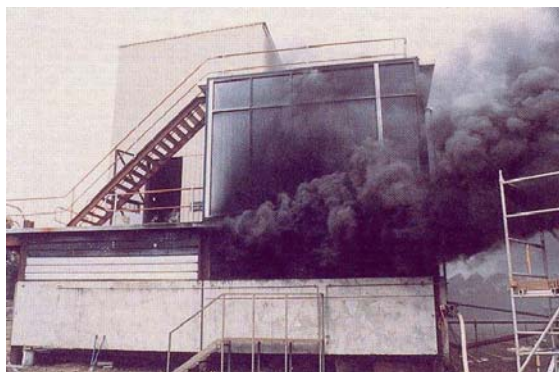
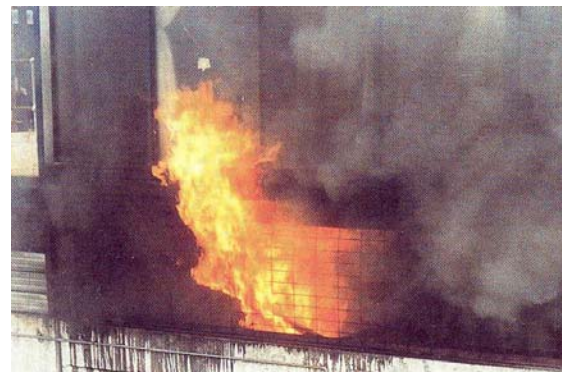
Figure 2-18: Car fire test photos, reproduced from BHP (1990)

Smoke produced from car fire issuing out of the car park structure

Flame and smoke reaching the office window above the car park

A sprinkler system was installed in the building; the ventilation of the building was by natural means. Similar to the tests in a closed car park (section 2.2.4.2), the measurements taken in this test program included inside air temperature, steel temperature, smoke optical density, carbon monoxide concentration, hydrogen chloride and hydrogen cyanide concentration. The large quantity of black smoke generated in fire was observed in all the tests; this can be seen from the photo on left in Figure 2-18 for a test using five vehicles.

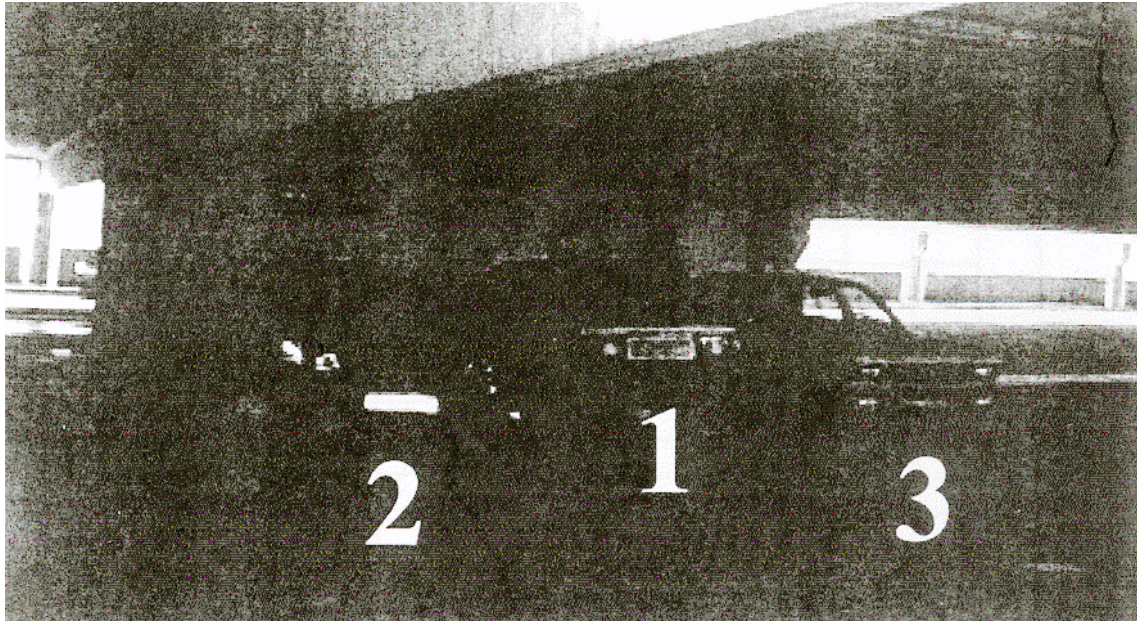
Figure 2-19: Car fire test photo, reproduced from Schleich et al. (1999)

Three cars more than ten years old were parked in parallel as shown in Figure 2-19, with separation distances at 0.5 m and 0.7 m between the cars. The fuel tank of the middle car was half full; the other two cars had 10 litres of petrol in the tank. The fire was started from middle car by ignition of fuel in a steel tray underneath the front seat. The measurements taken during the test included gas temperatures under the ceiling, heat fluxes at various positions and mass loss rate of the middle car.

In Test 1, the windows of all the cars were closed. Consequently, the fire in the test car went out within three minutes of ignition due to oxygen depletion.

Two full scale tests (Schleich et al., 1999) were performed in a semi-closed concrete car park in Amsterdam, 1996. This car park was a concrete structure measuring 55 m by 85 m with a height of 3 m.

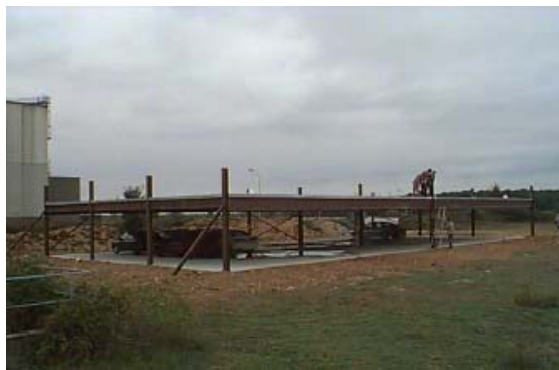
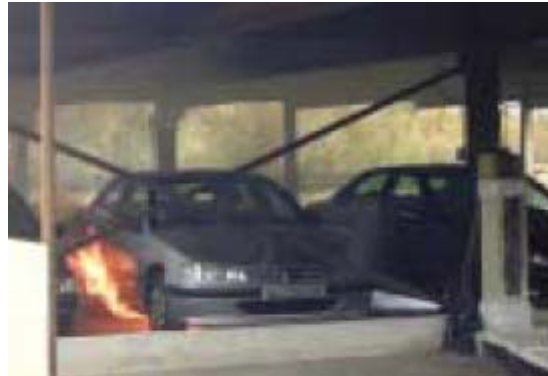
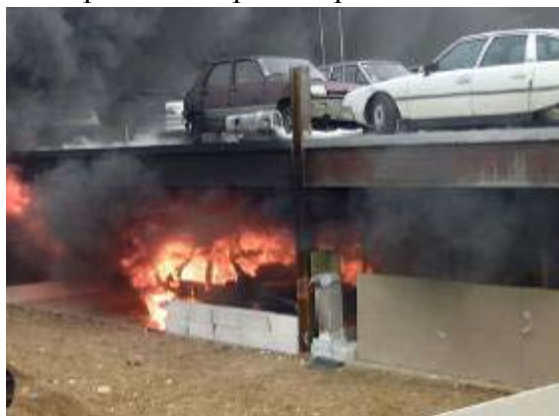
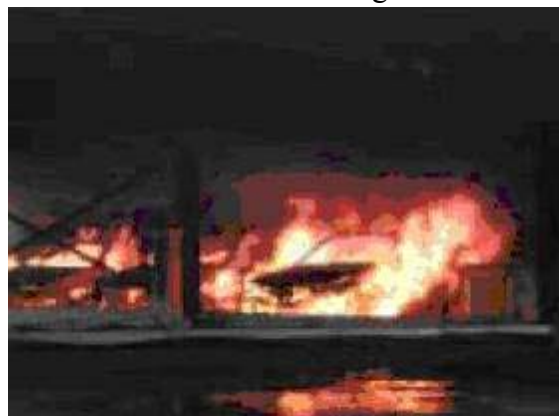
Figure 2-20: Car fire test photos, reproduced from Anon (2000)

Purpose built open car park structure

One minute after the ignition

Nine minutes after the ignition

Twenty-one minutes after the ignition

At four minutes after ignition of the middle car, the fuel tank was involved causing spill of preheated fuel on the ground. The fire then spread to two other cars parked on both sides. The fire development was most severe from three to ten minutes after ignition; during this time flame was seen extending out of the car park and reaching one or two metres above the upper level of the structure. The fire started to decay at 15 minutes after ignition and was close to extinction at 35 minutes after ignition. It

was considered that the wind condition had contributed to the rapid development of fire spread. The progress of the fire can be seen from photos in Figure 2-20.

CTICM built a two-level car park using unprotected steel work and concrete slab construction in Vernon, France and conducted a full scale fire test in this structure (Anon, 2000). The car park shown in Figure 2-20 measured 15 m by 32 m; the height between two levels was 3 m.

Three up-market cars parked in parallel were used in the test. The middle car was ignited first by a tray containing 1.5 litres of heptane under the gearbox. The measurements taken during the test included: ambient temperatures in the vehicle and structure, temperatures of the structural elements, vertical and horizontal displacements of the structural elements exposed to the fire, wind velocity and orientation.
